# Liquid Oxygen Cylinder Explosion

- Improper methods used to render scrap cylinder unserviceable
- Unsafe modifications to cylinder design

The incident described in the following presentation did not involve an Airgas company.

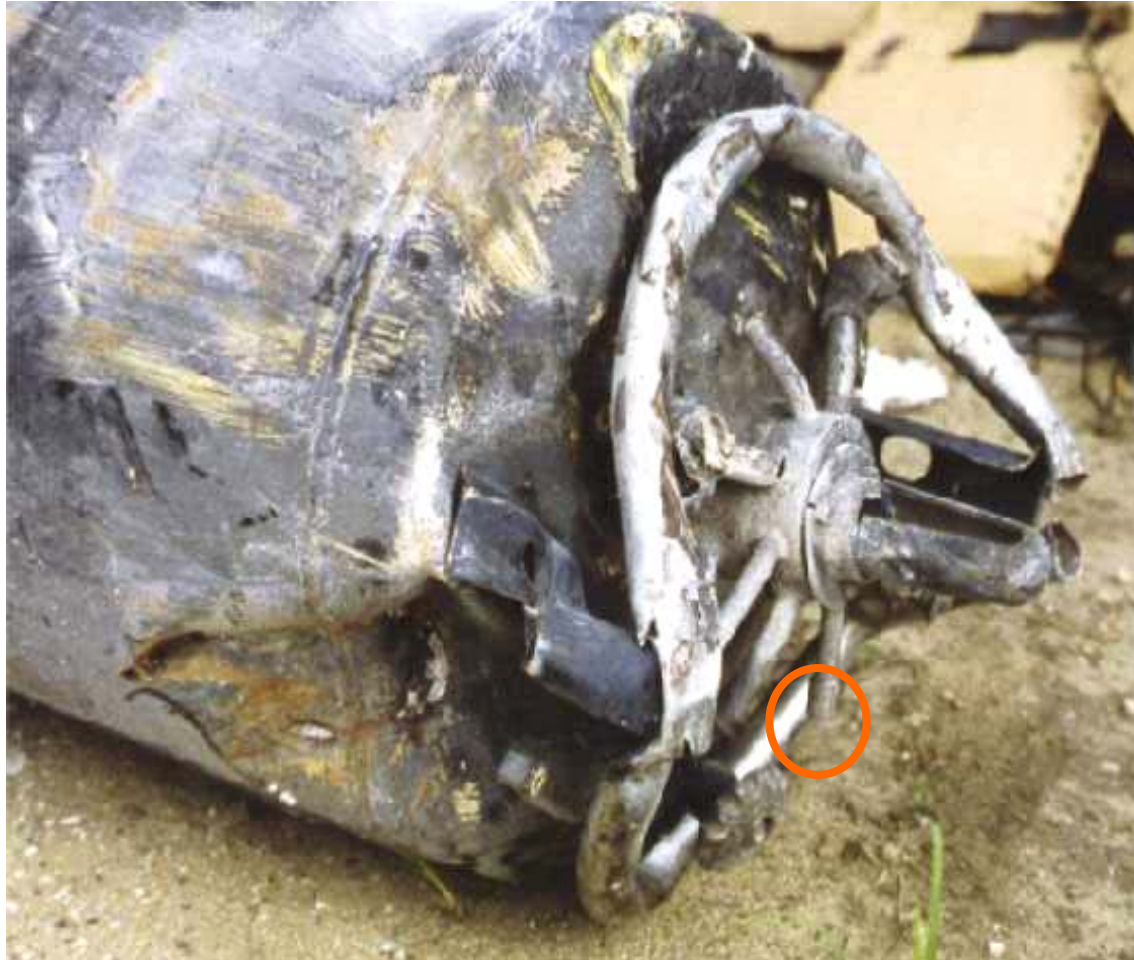
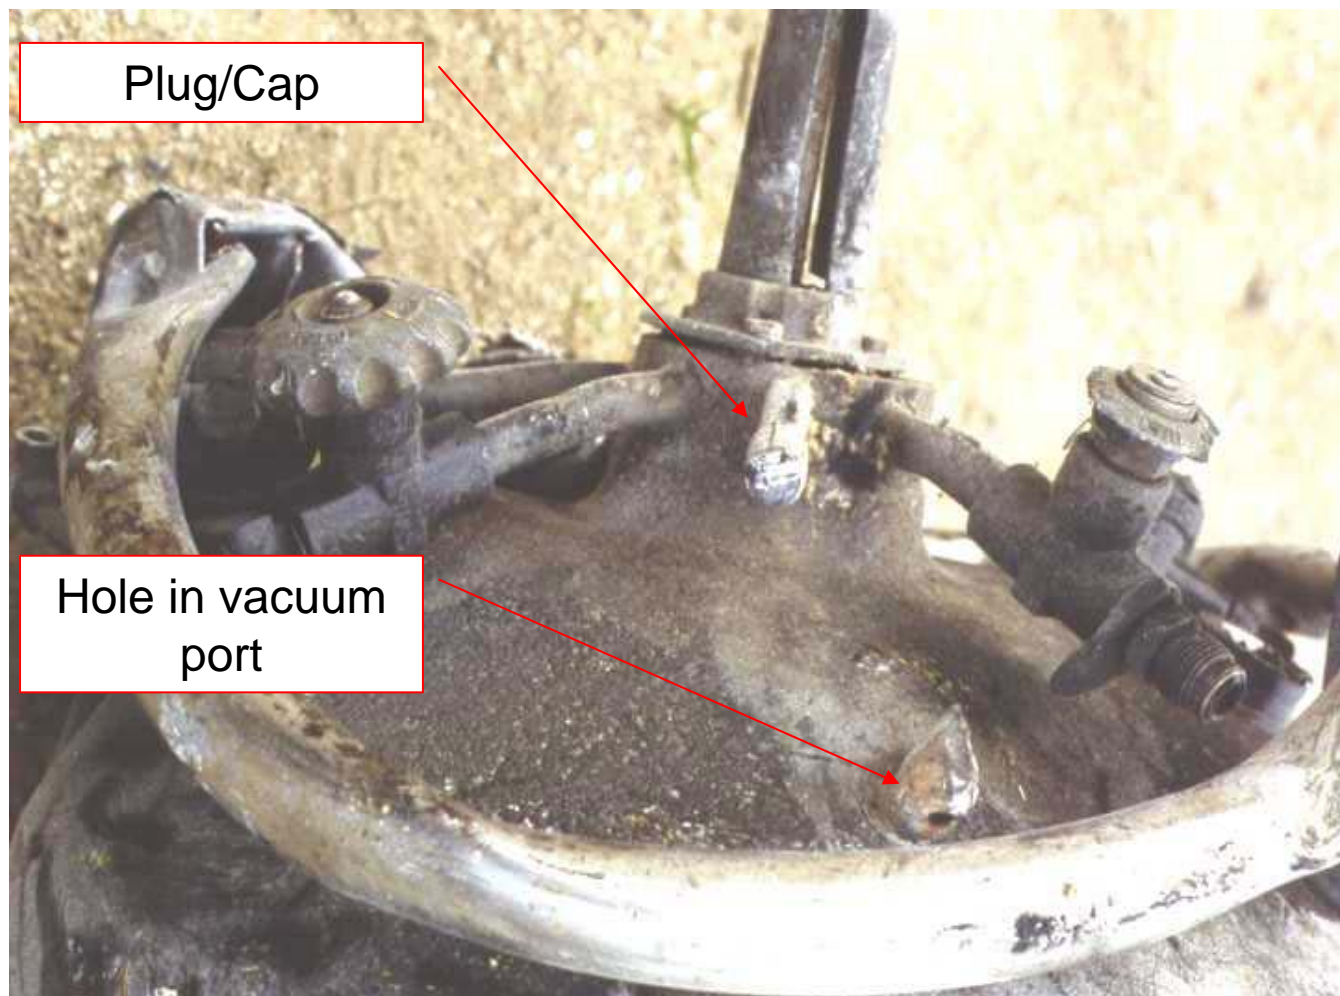
- The PRDs were removed and plugged
- The cylinder was filled while onboard a pickup truck
- The cylinder, which had no vacuum, was now unable to vent excess pressure

PRD location was plugged using a threaded cap

Plug/Cap

Hole in vacuum  
port

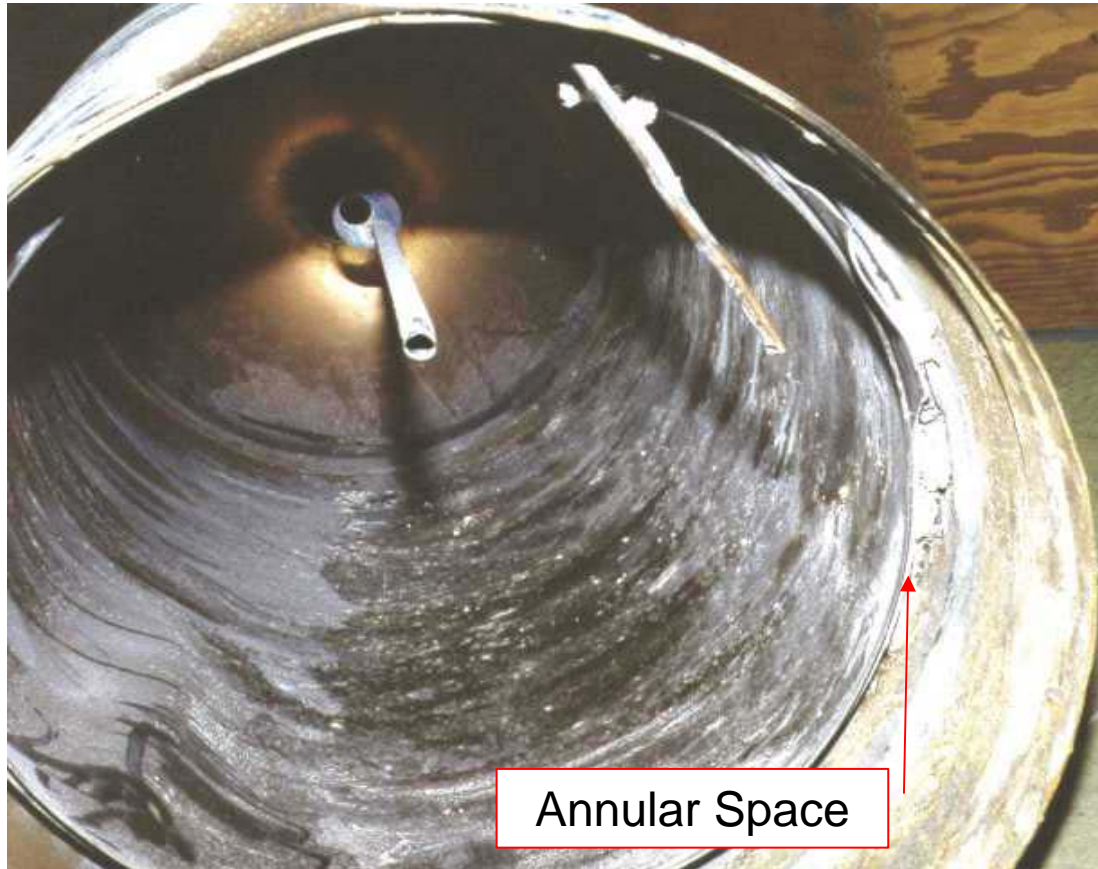
# Both inner and outer shells separated at bottom welds

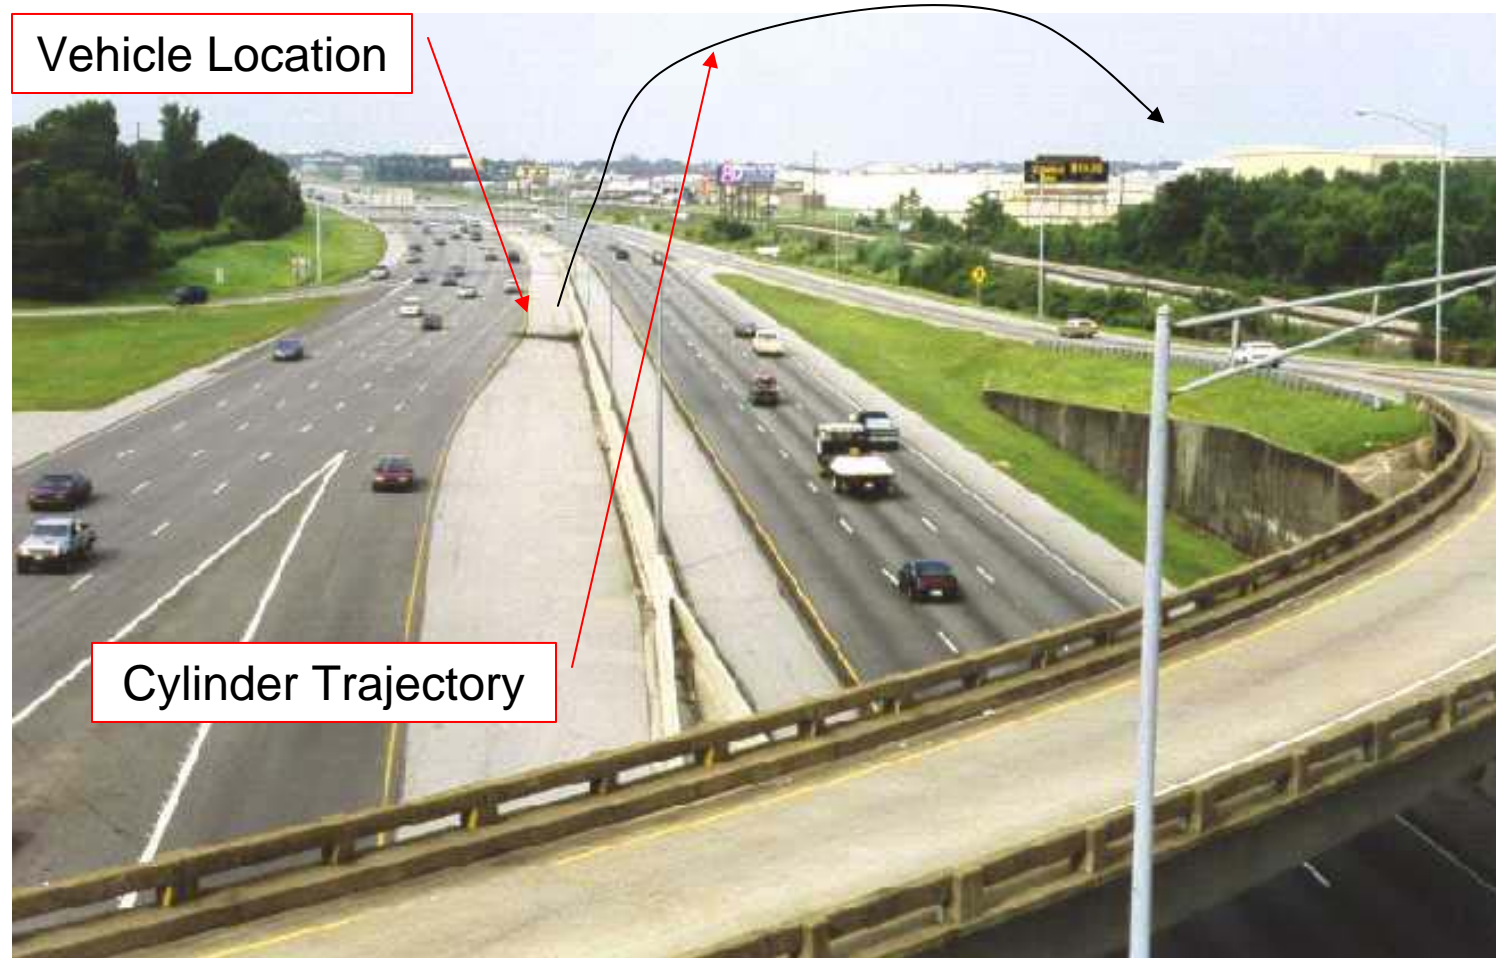
# Cylinder exploded at 12:40 PM while transport vehicle was parked on busy Interstate highway

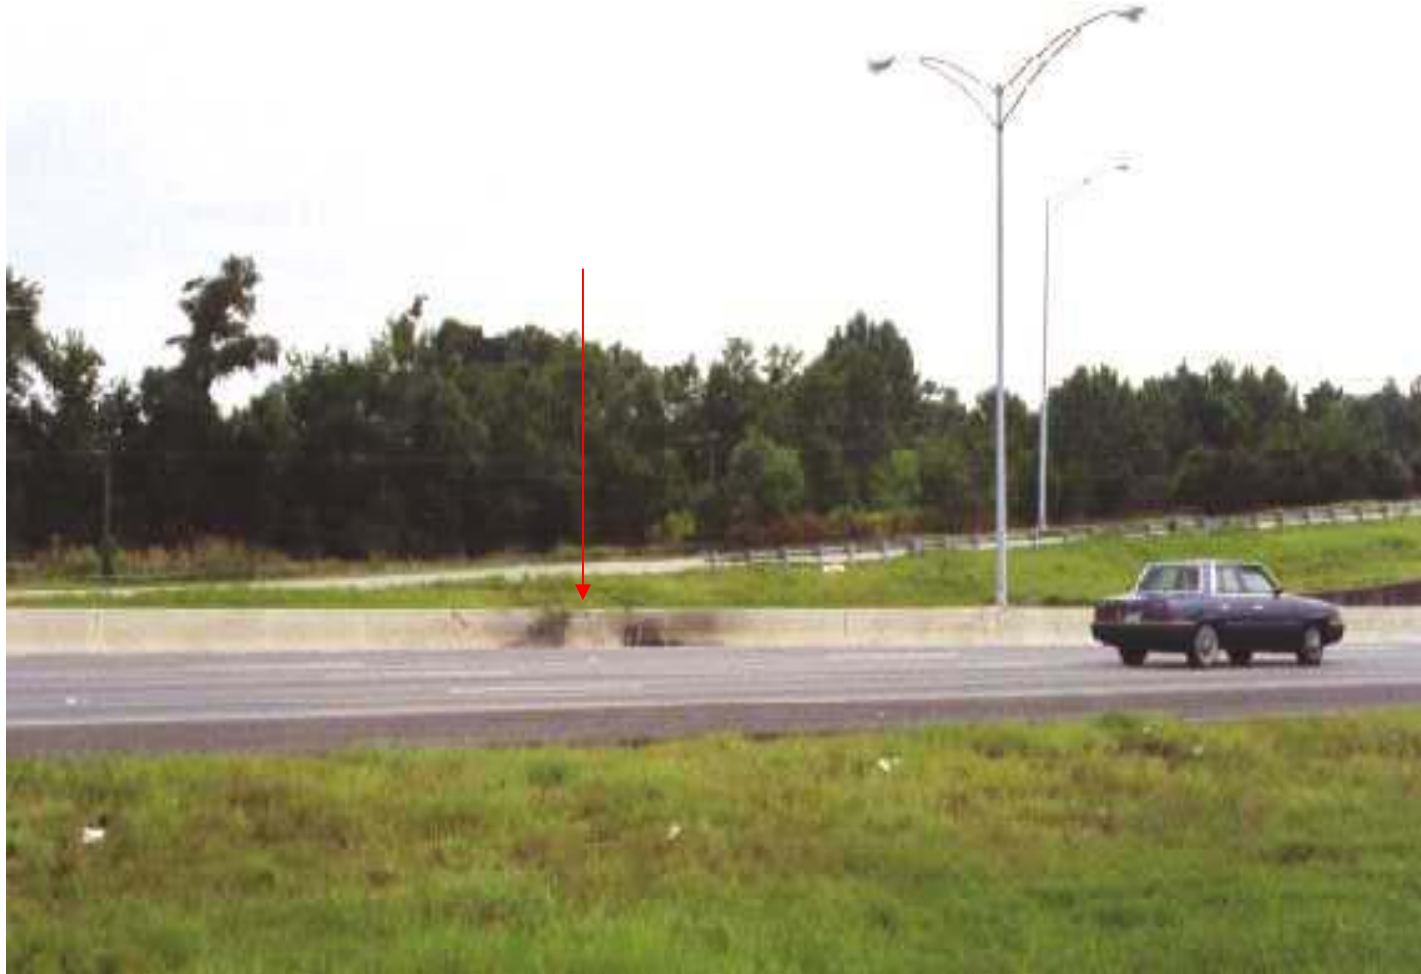
The blast blew one individual across 5 lanes of traffic. The other was blown approximately 40 feet. Both survived

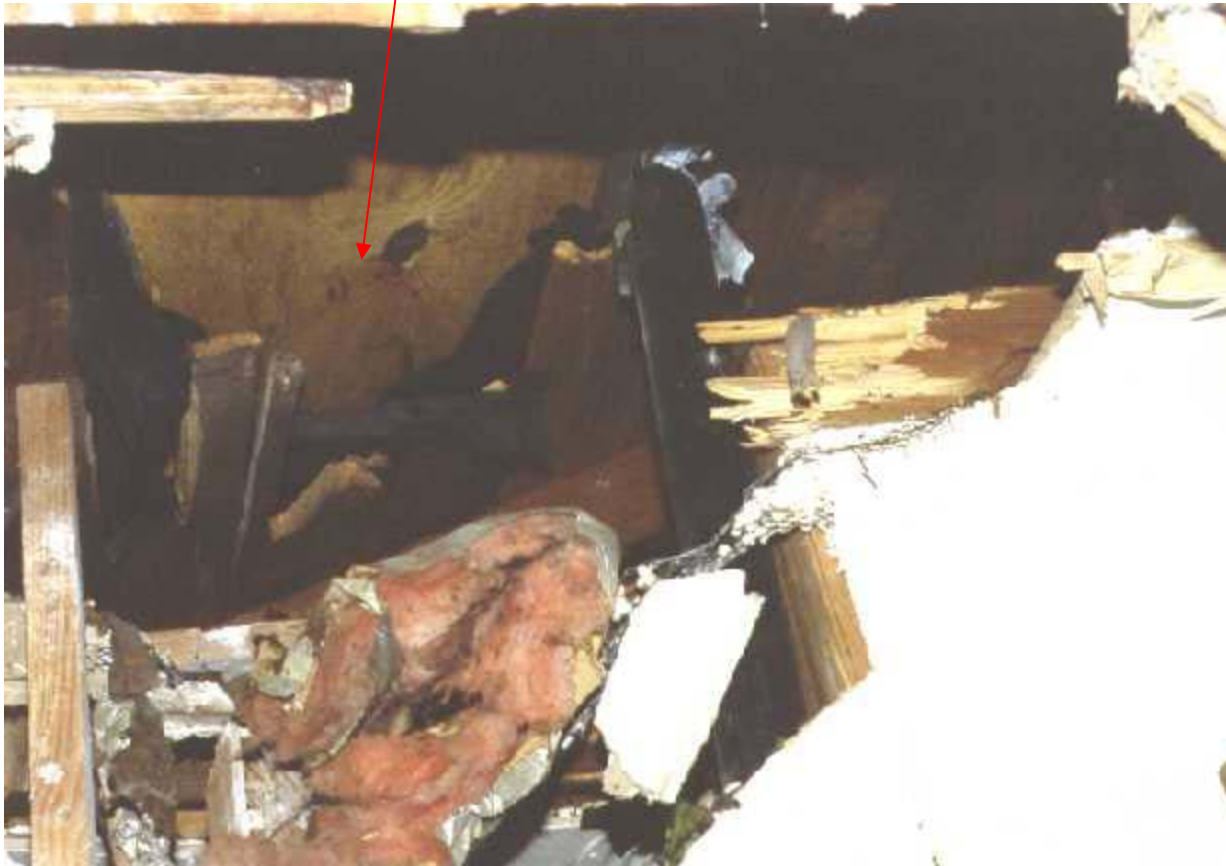
Cylinder flew approximately ¼ mile before plunging through the roof of an apartment, severing a main natural gas line and coming to rest in the living space

Plywood applied over hole in roof

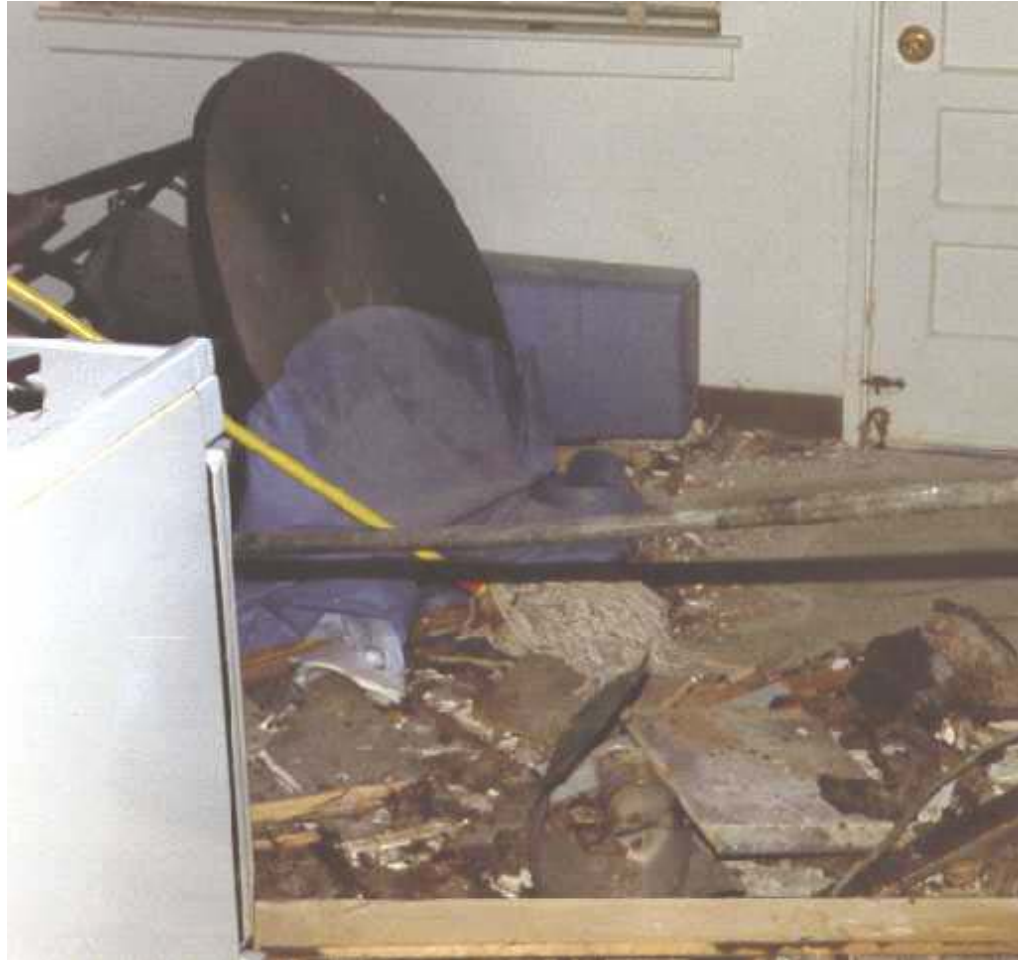
Despite heavy damage, no injuries to apartment tenants were reported
